**Flood Control Project Maintenance
Levee Inspections**

Maintenance Issue Types Only, Levee Inspection Report By Mile - Spring 2018

Yolo County Service Area 6

Waterway	Bank	Unit Miles	Inspection Start/End	Inspector
Unit No. 01 Right Bank of Sacramento River at Knights Landing	Right	5.87	03/15/2018 03/15/2018	Zach Jojola

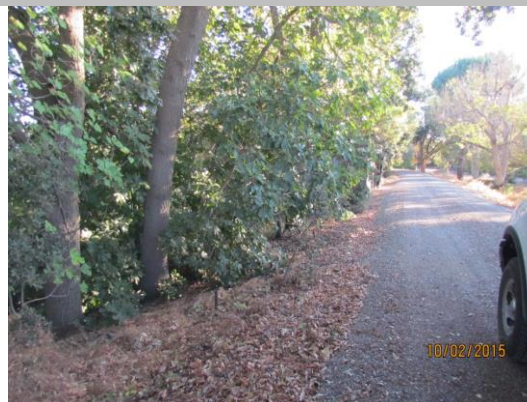
Photo 1 of 1 : SP_2018_NA0022_350_6_20180306_00007.jpg

View of the vegetation and trees on the waterward side of the levee looking downstream. Fall 2015.

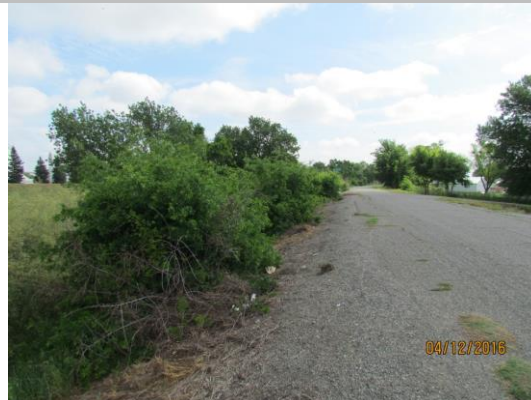
Photo 1 of 1 : SP_2018_NA0022_350_102_20180306_00064.jpg

View of the trees on the waterward side of the levee looking downstream. Spring 2016.

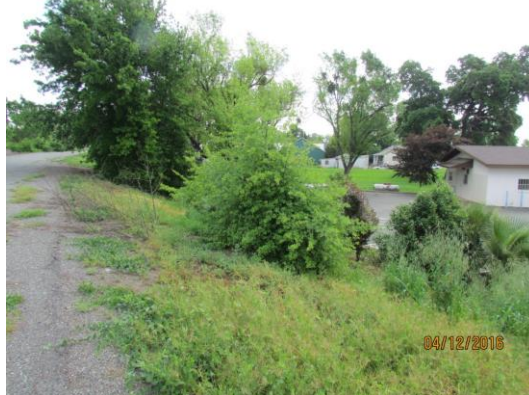
Photo 1 of 1 : SP_2018_NA0022_350_104_20180306_00065.jpg

View of the tree on the landward side of the levee looking downstream.
Spring 2016.

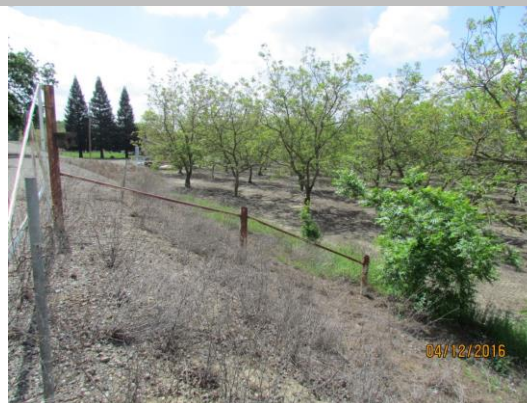
Photo 1 of 1 : SP_2018_NA0022_350_112_20180306_00066.jpg

View of the tree at the toe of the levee on the landward side looking downstream. Spring 2016.

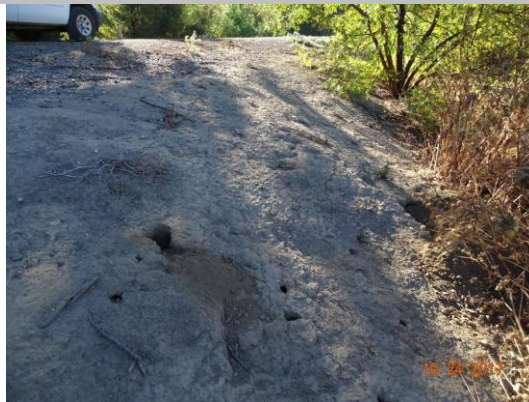
Photo 1 of 2 : SP_2018_NA0022_350_119_20180306_00069.jpg

Updated view of rodent holes on landside slope. Fall 2017.

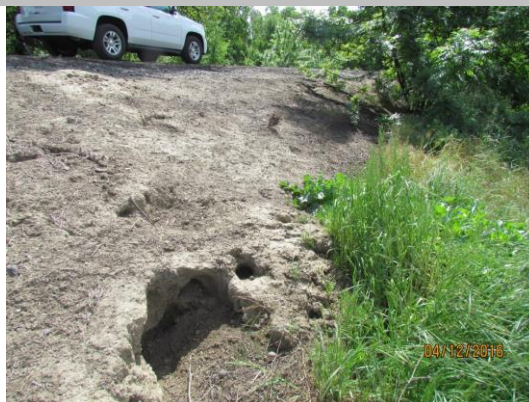
Photo 2 of 2 : SP_2018_NA0022_350_119_20180306_00070.jpg

View of the rodent hole on the landward side of the levee. Spring 2016.

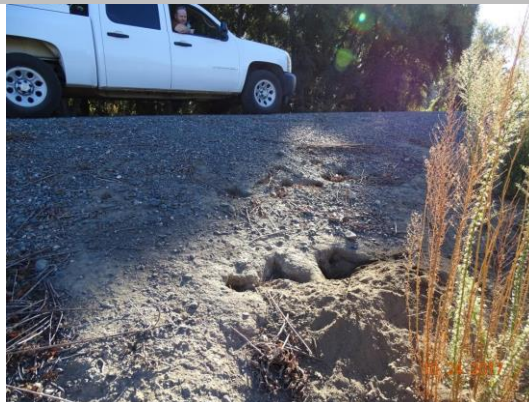
Photo 1 of 2 : SP_2018_NA0022_350_117_20180306_00067.jpg

View of rodent holes on landside slope. Fall 2017.

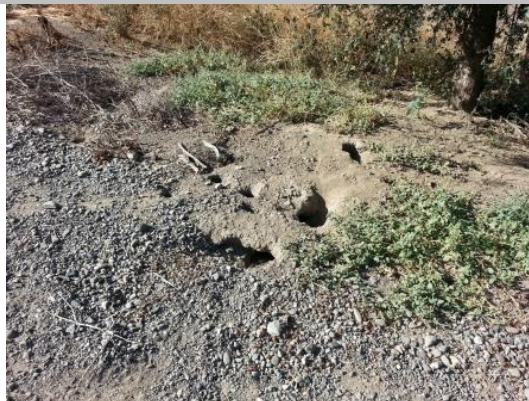
Photo 2 of 2 : SP_2018_NA0022_350_117_20180306_00068.jpg

Series of animal burrows on LS slope of the levee. Fall inspection 10/07/2016.

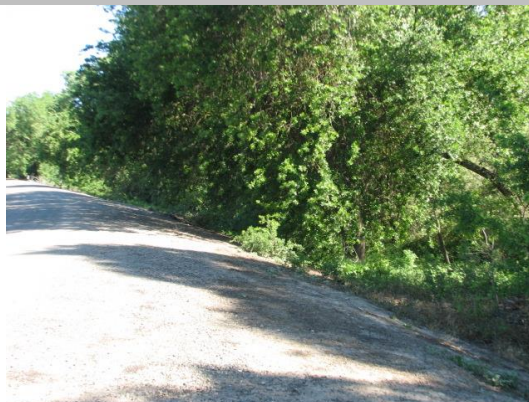
Photo 1 of 1 : SP_2018_NA0022_350_19_20180306_00017.jpg

LM Start	2.03	Rating **	M	Issue No.	19
LM End	2.04	Issue Type +	Ma	Location *	WS
Category	Earthen Levee			GPS Latitude/Longitude	
				Start	End
Item	Vegetation			38.794344 °	38.794259 °
				-121.695670 °	-121.695672 °
DWR ID	DWR_NA0022_01_s_2012_19				
Comment Code					
V2 : Remove the wild growth other than native grasses from the levee slopes.					
Inspector Comment

Trees and brush obstruct visibility on the berm area. Spring 2014

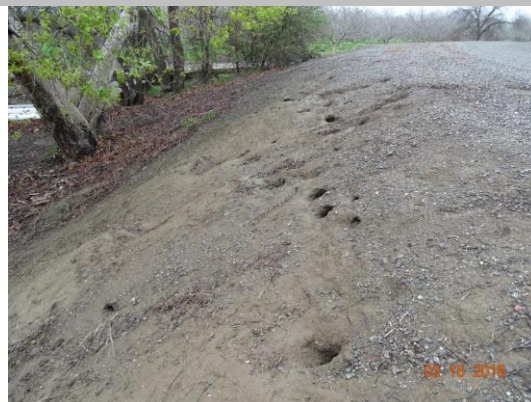
Photo 1 of 2 : SP_2018_NA0022_350_8_20180315_00143.jpg

View of rodent holes on the landside slope. Spring 2018.

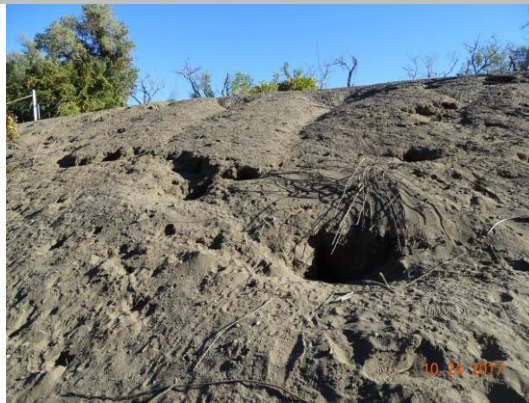
Photo 2 of 2 : SP_2018_NA0022_350_8_20180306_00009.jpg

View of rodent holes on landside slope. Fall 2017.

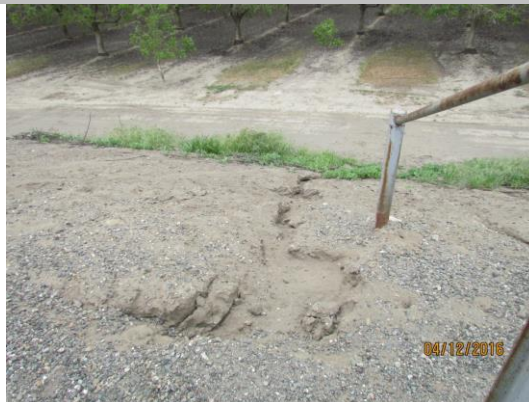
Photo 1 of 2 : SP_2018_NA0022_350_35_20180306_00025.jpg

LM Start	2.24	Rating **	M	Issue No.	35
LM End	2.28	Issue Type +	Ma	Location *	LS
Category	Earthen Levee			GPS Latitude/Longitude	
				Start	End
Item	Erosion / Bank Caving			38.791652 °	38.791172 °
				-121.695403 °	-121.695165 °
DWR ID	DWR_NA0022_01_s _ 2016_35				
Comment Code					
E2 : Schedule repair of erosion site prior to the next inspection.					
Inspector Comment					
Repair rills on landward side of the levee.

Erosion is on the landward side of the levee. Spring 2016.

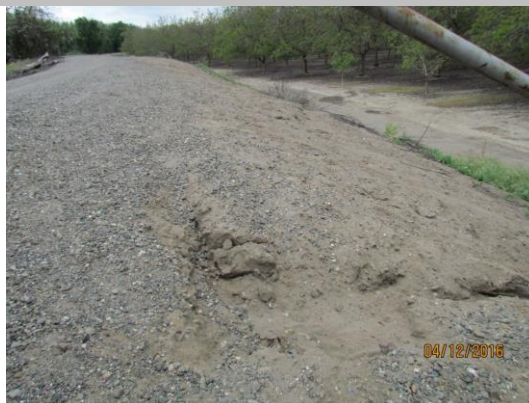
Photo 2 of 2 : SP_2018_NA0022_350_35_20180306_00026.jpg

LM Start	2.24	Rating **	M	Issue No.	35 (cont)	
LM End	2.28	Issue Type +	Ma	Location *	LS	
Category	Earthen Levee			GPS Latitude/Longitude		
				Start		End
Item	Erosion / Bank Caving			38.791652 °		38.791172 °
				-121.695403 °		-121.695165 °
DWR ID	DWR_NA0022_01_s_2016_35					
Comment Code						
E2 : Schedule repair of erosion site prior to the next inspection.						
Inspector Comment						
Repair rills on landward side of the levee.

Perspective view of the erosion on the landward side of the levee. Spring 2016.

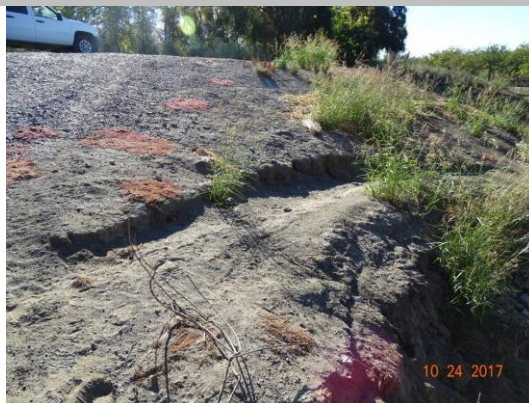
Photo 1 of 4 : SP_2018_NA0022_350_96_20180306_00060.jpg

Updated view of erosion on landside slope. Fall 2017.

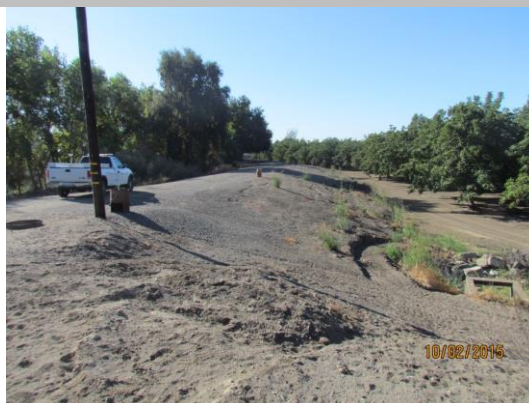
Photo 2 of 4 : SP_2018_NA0022_350_96_20180306_00061.jpg

Perspective view of the erosion around the pipe on the landward side of the levee looking downstream. Fall 2015.

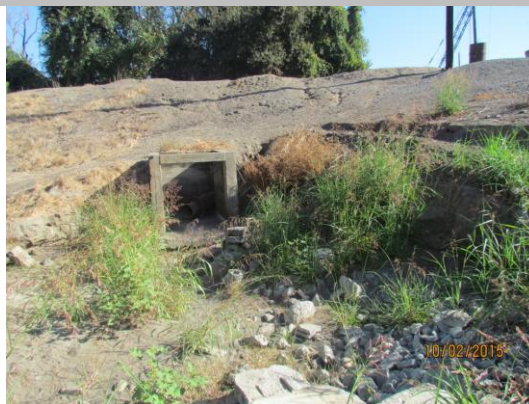
Photo 3 of 4 : SP_2018_NA0022_350_96_20180306_00062.jpg

The erosion is within the levee prism. Fall 2015.

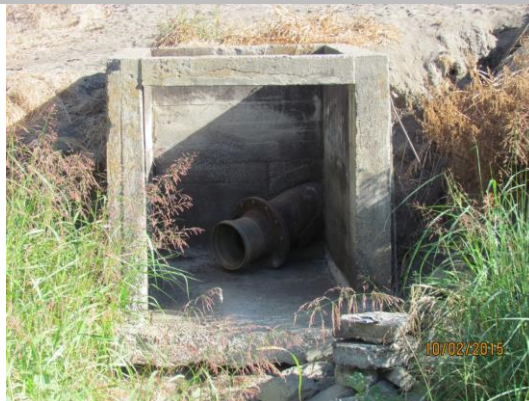
Photo 4 of 4 : SP_2018_NA0022_350_96_20180306_00063.jpg

View of the pipe in the concrete box. Fall 2015.

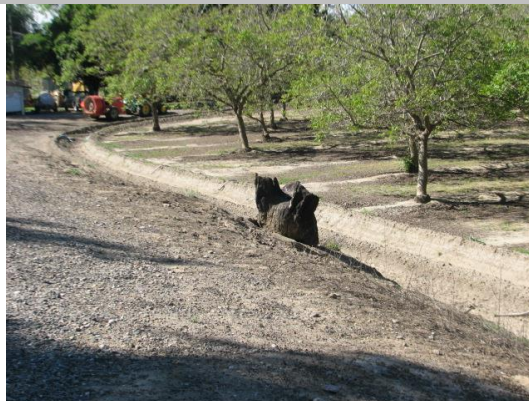
Photo 1 of 1 : SP_2018_NA0022_350_37_20180306_00029.jpg

Tree stump decomposing and may pose a risk to the levee. Spring 2014

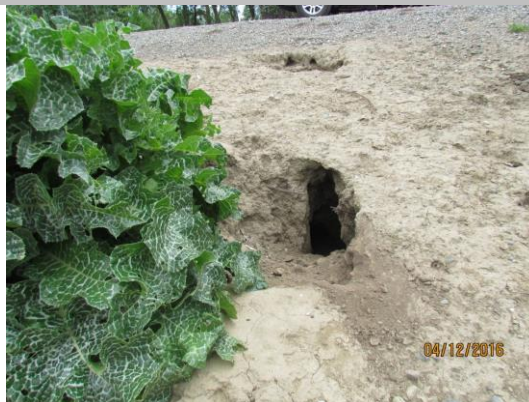
Photo 1 of 2 : SP_2018_NA0022_350_123_20180306_00071.jpg

LM Start	2.52	Rating **	U	Issue No.	123
LM End	2.52	Issue Type +	Ma	Location *	LS
Category	Earthen Levee			GPS Latitude/Longitude	
				Start	End
Item	Animal Control			38.787768 °	38.787768 °
				-121.694295 °	-121.694295 °
DWR ID	DWR_NA0022_01_s_2016_123				
Comment Code					
A3 : No rodents visible, but rodent burrows visible; need to backfill and compact or grout burrows.					
Inspector Comment

View of the rodent hole next to a tree stump on the landward side of the levee. Spring 2016.

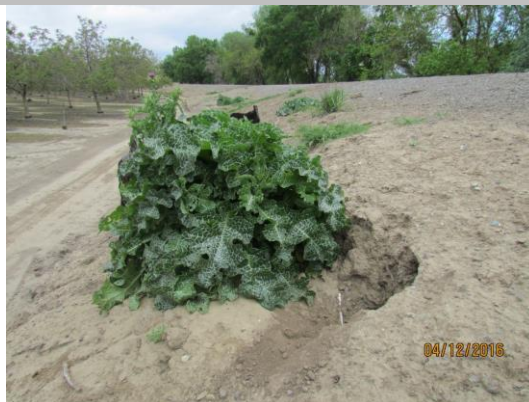
Photo 2 of 2 : SP_2018_NA0022_350_123_20180306_00072.jpg

Perspective view of the rodent hole looking upstream. Spring 2016.

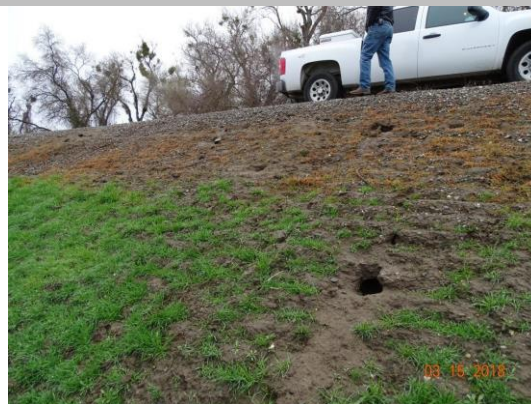
Photo 1 of 1 : SP_2018_NA0022_350_52_20180315_00144.jpg

View of rodent holes on the landside slope. Spring 2018.

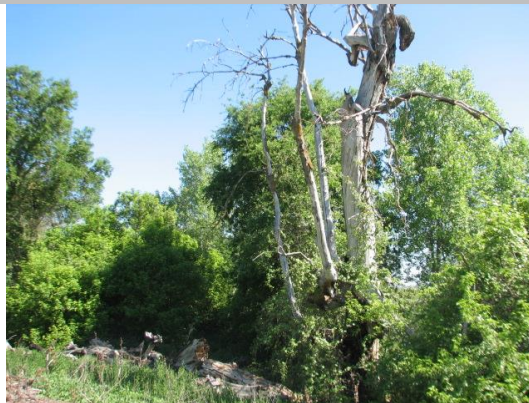
Photo 1 of 2 : SP_2018_NA0022_350_47_20180306_00034.jpg

Some trees have fallen and others are dying and need to be monitored.
The trees may pose a threat to the levee. Spring 2014

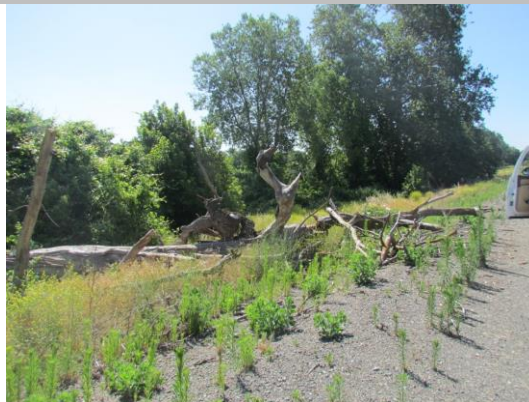
Photo 2 of 2 : SP_2018_NA0022_350_47_20180306_00035.jpg

View of the fallen tree on the waterward side of the levee looking downstream. Spring 2015.

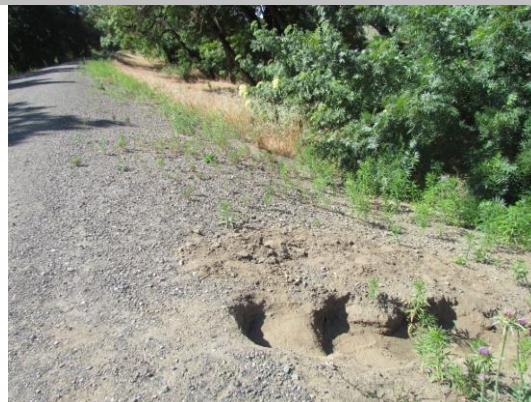
Photo 1 of 3 : SP_2018_NA0022_350_79_20180306_00046.jpg

LM Start	3.41	Rating **	M	Issue No.	79
LM End	3.41	Issue Type +	Ma	Location *	LS
Category	Earthen Levee			GPS Latitude/Longitude	
				Start	End
Item	Slope Stability			38.777204 °	38.777204 °
				-121.687045 °	-121.687045 °
DWR ID	DWR_NA0022_01_s_2015_79				
Comment Code					
S2 : Repair the levee slope damaged by foot traffic and prevent access where possible.					
Inspector Comment					
Stairs have eroded and turned into a slope stability issue.

View of the stairs on the landward side of the levee looking downstream. Spring 2015.

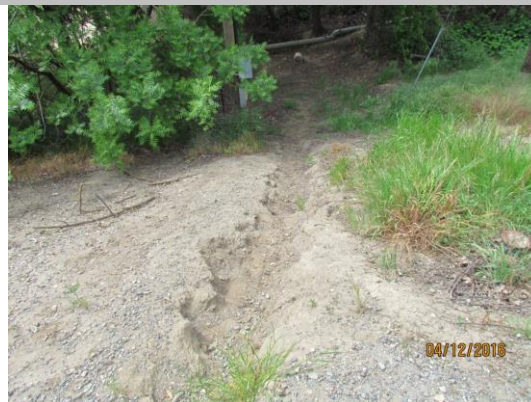
Photo 2 of 3 : SP_2018_NA0022_350_79_20180306_00047.jpg

Dirt stairs has eroded and caused a slope stability. Spring 2016.

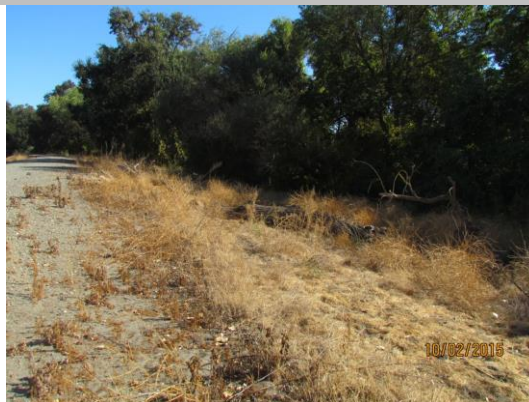
Photo 1 of 1 : SP_2018_NA0022_350_89_20180306_00057.jpg

View of the fallen tree on the waterward side of the levee looking upstream. Fall 2015.

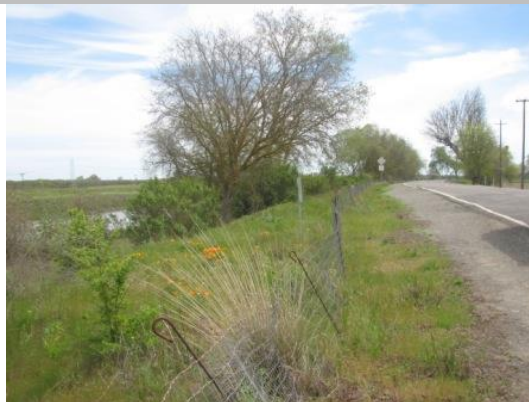
Photo 1 of 2 : SP_2018_NA0022_350_36_20180306_00027.jpg

Another view of the site.

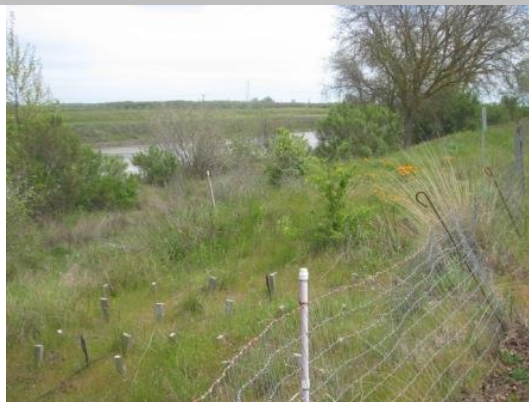
Photo 2 of 2 : SP_2018_NA0022_350_36_20180306_00028.jpg

Fence, irrigation and stakes in the revegetation site.

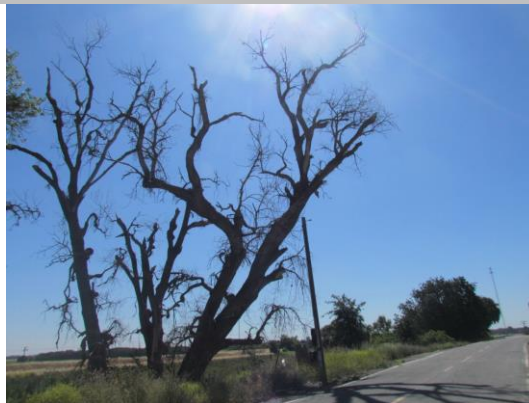
Photo 1 of 1 : SP_2018_NA0022_350_81_20180306_00049.jpg

View of the dying tree on the waterward side of the levee looking downstream. Spring 2015.

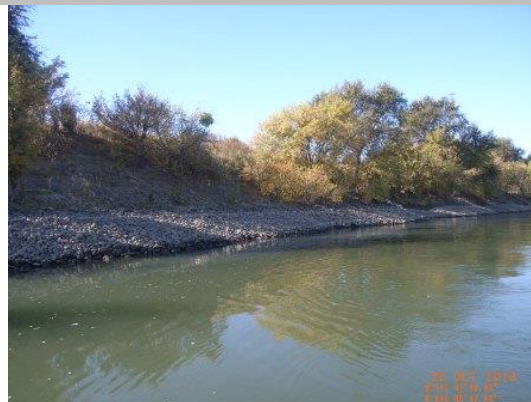
Photo 1 of 1 : SP_2018_NA0022_350_3_20180306_00002.jpg

LM Start	4.66	Rating **	M	Issue No.	3
LM End	4.86	Issue Type +	Ma	Location *	WS
Category	Supplemental			GPS Latitude/Longitude	
				Start	End
Item	2015 USACE Erosion Survey, DRAFT			38.763486 °	38.763313 °
				-121.687567 °	-121.684038 °
DWR ID	DWR_NA0022_01_s_2016_3				
Comment Code					
Inspector Comment					
2009 - Erosion into the levee toe. Some cobbles have been dumped into the erosion pockets. 2010 - Old cobble site starting to unravel. 2012 - Slope continues to steepen and new animal holes. 2013 - Downstream cobble is unraveling. 2015: No observed changes. [2015 Site ID: SAC_85-4_R]

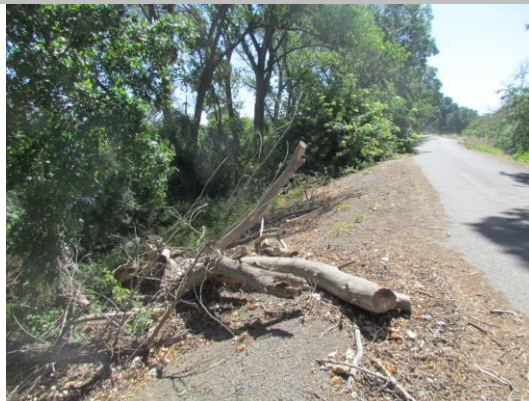
Photo 1 of 1 : SP_2018_NA0022_350_82_20180306_00050.jpg

View of the fallen tree on the waterward side of the levee looking downstream. Spring 2015.

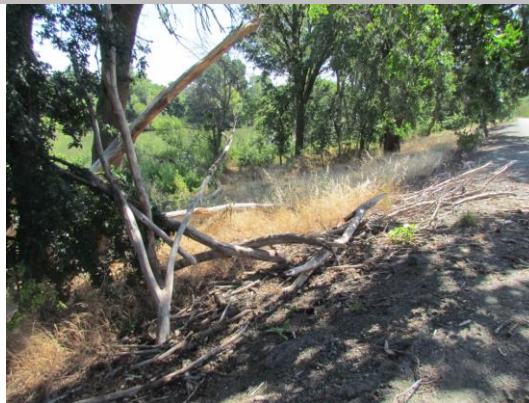
Photo 1 of 1 : SP_2018_NA0022_350_83_20180306_00051.jpg

View of the tree and tree limbs on the waterward side of the levee looking downstream. Spring 2015.
